COMMERCIAL WINDSTORM MITIGATION INSPECTION REPORT

Pinebrook Towne House Association, Inc.

COMMERCIAL WINDSTORM MITIGATION INSPECTION REPORT (OIR-B1-1802)

6741 121st Ave N

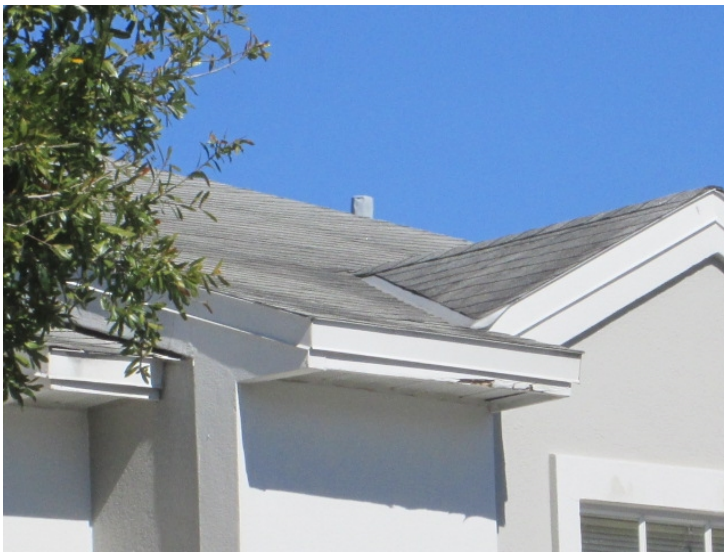
Roof Covering (Section 2)

Comments: | One or more roof coverings do not meet the minimum requirements
This building utilizes multiple roof sections of all different ages. This roof was verified as not meeting the requirements outlined on the mitigation affidavit. |

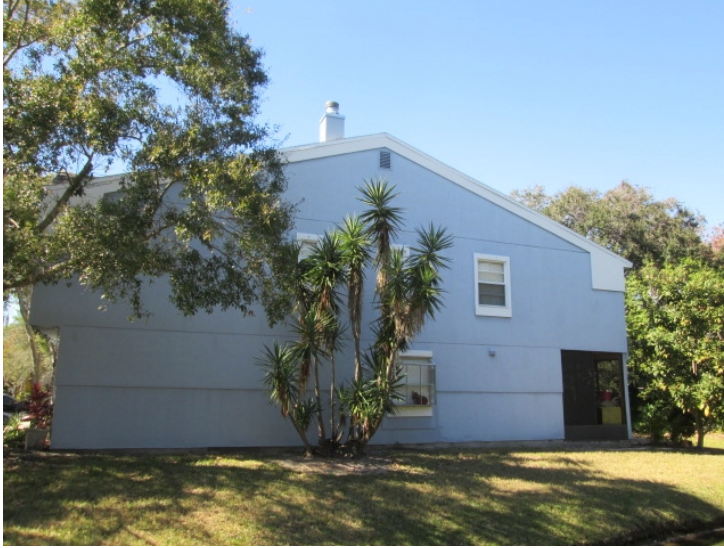
Roof Shape (Section 5)

Comments: | Other Roof
Inspection verified a gable roof shape. |
